Restoring mangroves for bank stabilisation on the Caboolture River

Margie Dickson¹, Misko Ivezich²

Abstract

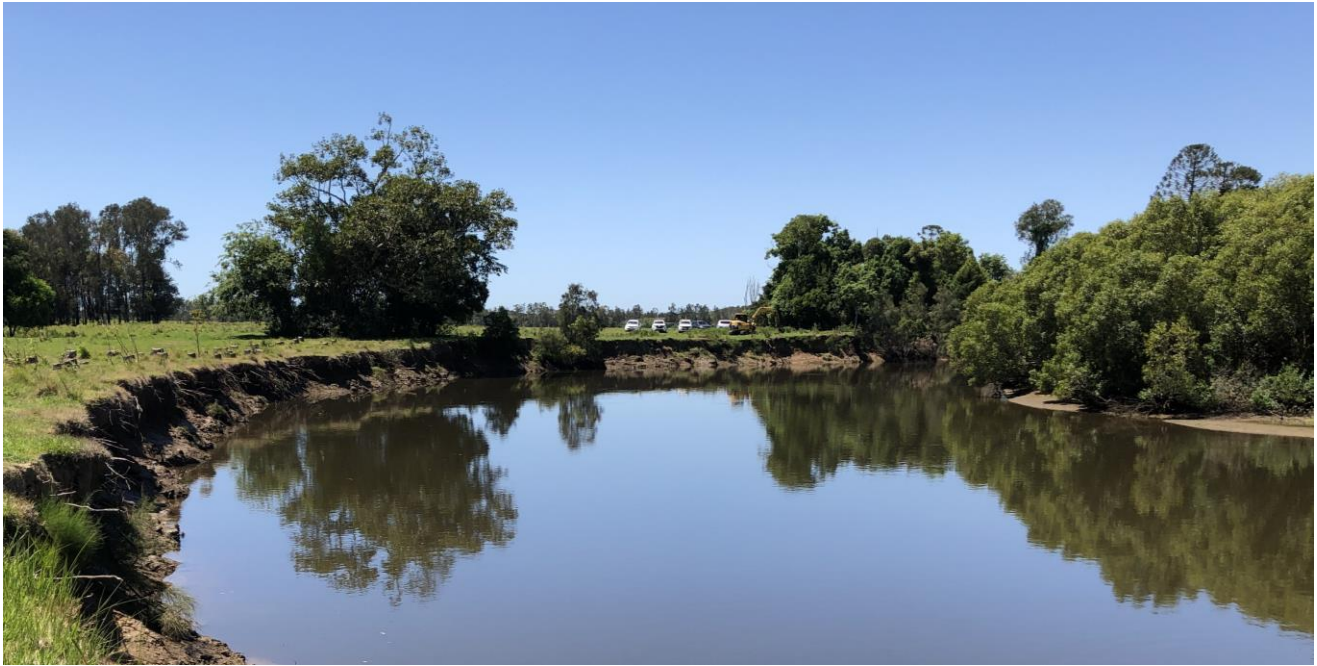
Scoping studies identified sections of bank suffering ongoing erosion. These are all located on outside bends, indicating that fluvial scour likely played a role in the initial destabilisation of unvegetated banks. However, studies during project scoping phase concluded that recreational boat wash is the most significant driver of ongoing erosion at these sites. Some colonisation of mangrove propagules and presence of young mangrove plants was observed at the sites, but these have not been able to form a resilient, self-stabilising community. Pre-existing mangroves noted in 2020 ecological surveys had significantly diminished after flooding in 2022.

Figure 1. Site B1 prior to works, November 2022. Note mature mangrove community on the opposite bank as seed source and reference ecological community.

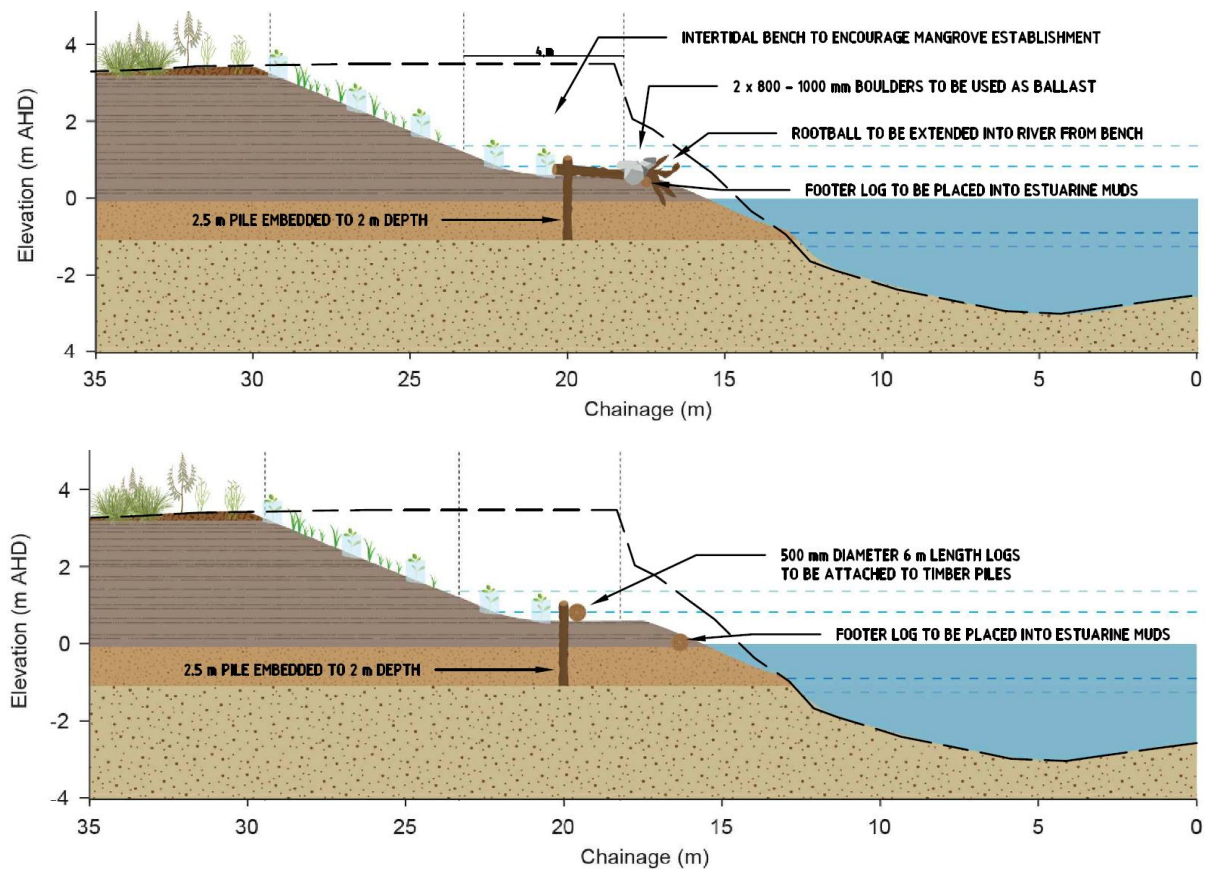
Figure 2: Section showing the proposed log groyne and pinned log arrangement Top: Log groyne. Bottom: Pinned log

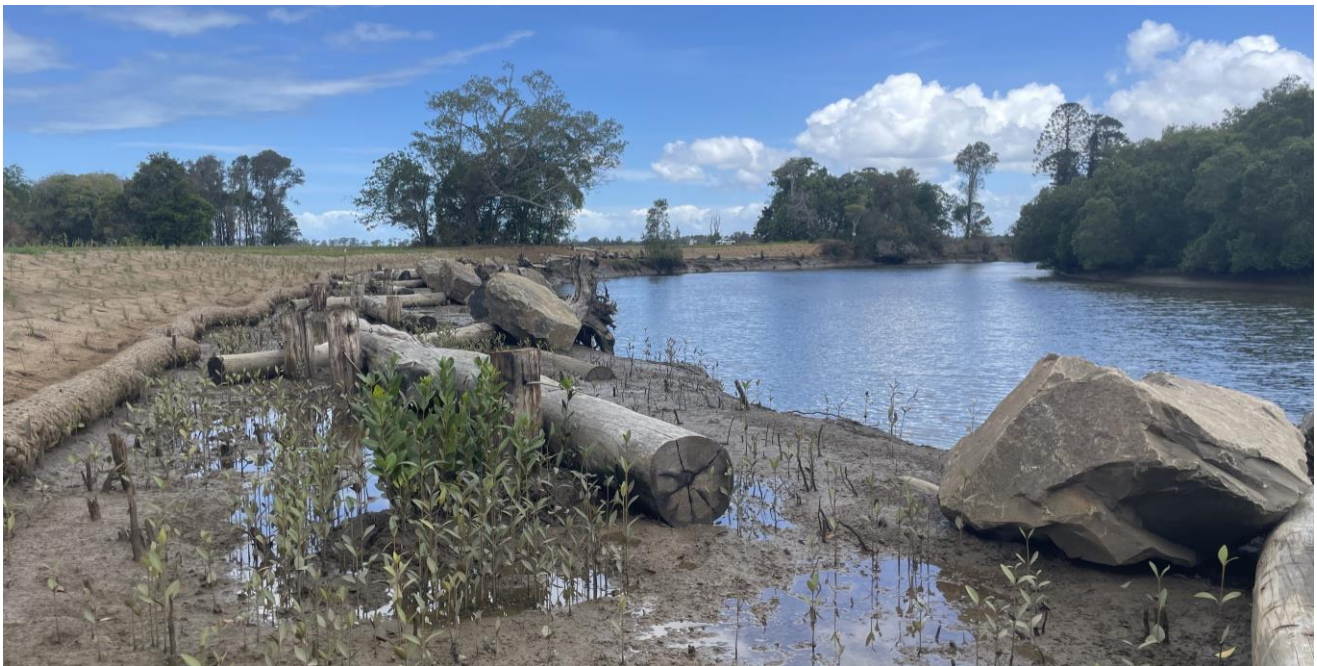
Figure 2. Site B1 after work, November 2023. Dense mangrove saplings in the foreground were translocated within the site during earthworks, while sparse saplings are natural recruits from the Spring 2023 grey mangrove fruiting event.

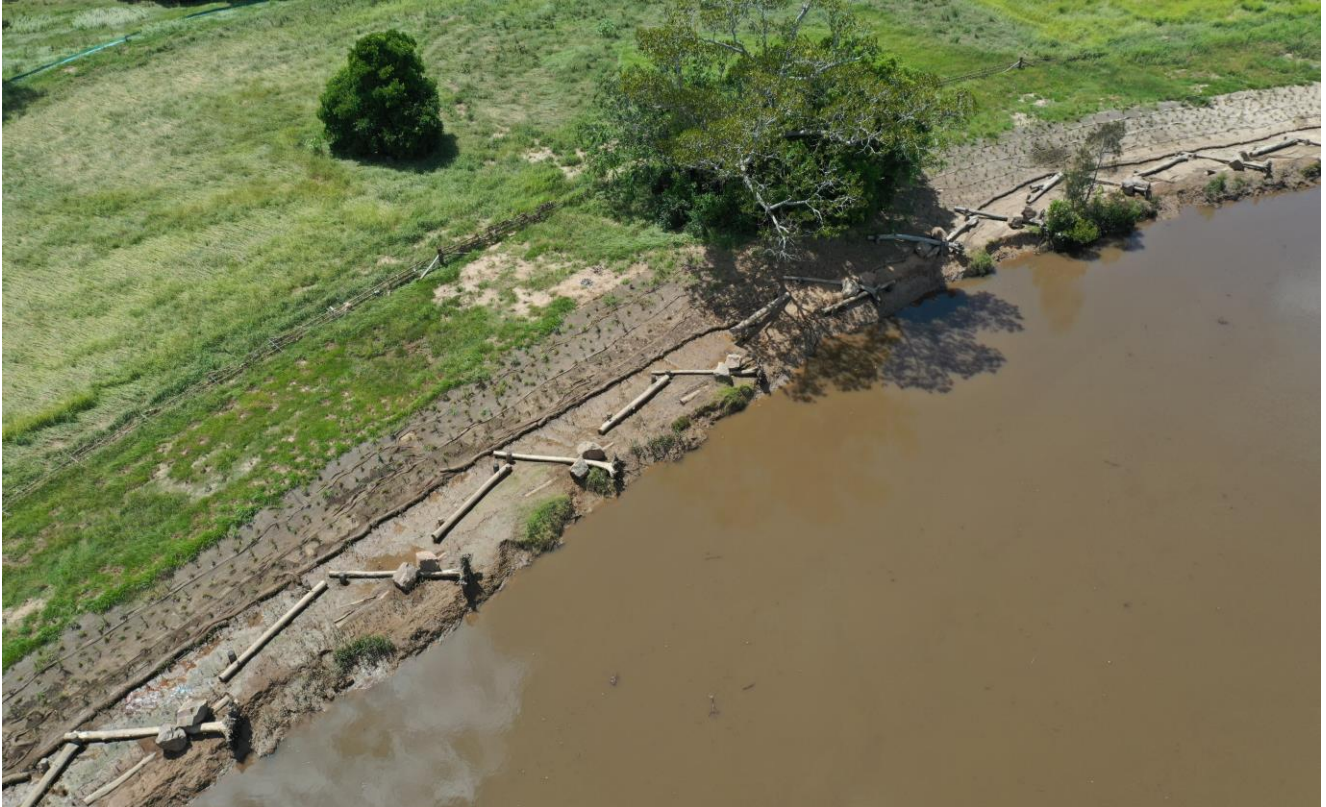
Figure 3. Site B1 post-flood, February 2024.

Riparian plantings and naturally recruited mangrove saplings all survived well, which was encouraging given the recent planting (<3 months since riparian planting at Site 5). The logs also remained generally stable, with the following post-flood observations:

- Logs were obviously buoyant against their restraints. One log on Site 5 had floated up and remained resting on top of its piles.
- Boulders on two rootball logs at the downstream end of Site B1 have slipped out of place and fallen off the bench, although the log itself remained in the correct orientation after the floodwaters subsided.

The pinned log was pushed back into place with a crowbar and cables were tightened. This highlights that inspection and possibly occasional replacement of the cables securing piled logs will be an important component of site maintenance over the medium term.

No repair was deemed necessary for the partial loss of restraint on a single rootball log. On subsequent sites, the boulders will be moved slightly to the landward side of the footer log.

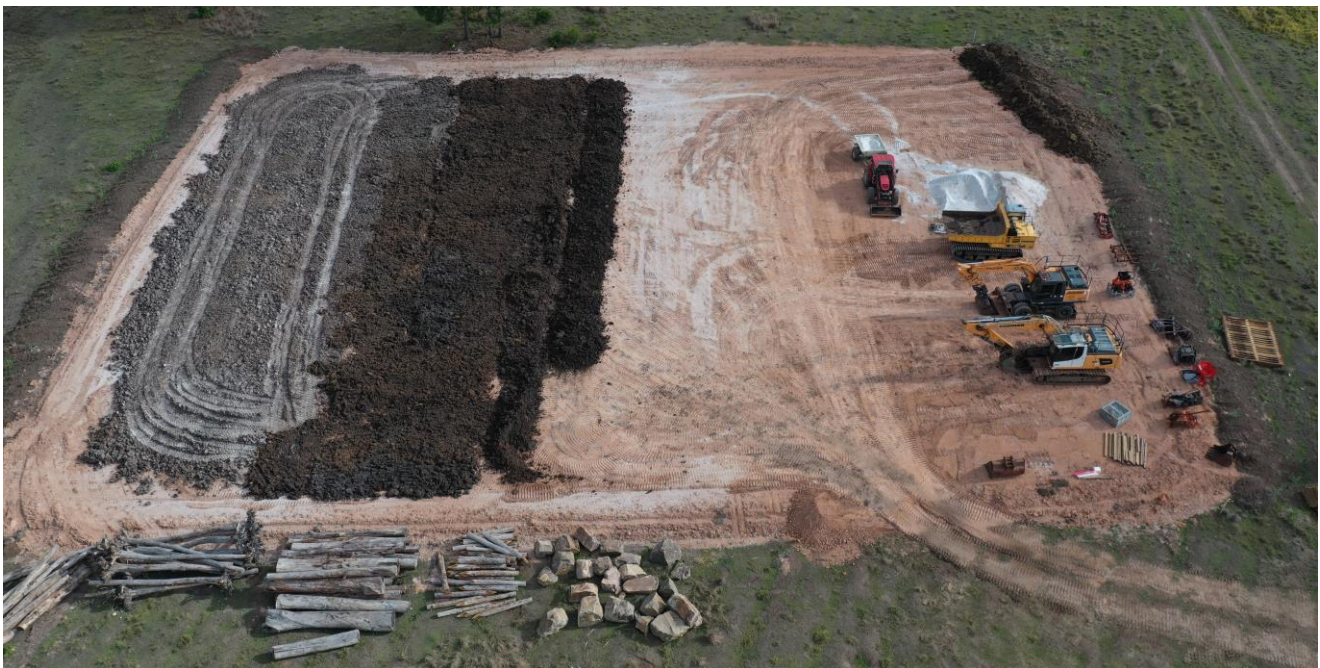
In areas of the site disturbing ASS/PASS, the exposed surface of the reprofiled bank presents a low risk of oxidation, due to ongoing tidal wetting/drying cycles identical to the in-situ state. However, spoil from bank reprofiling will fully oxidise over time. Liming was required to treat ASS/PASS spoil. At the three completed sites, this was undertaken on site on a clay-lined treatment pad (Figure 4). Offsite treatment at a licenced third-party facility was the preferred option for sites where onsite placement was not acceptable to the landholder or no elevated land was available for the treatment pad. Both on-site and off-site treatment options were a significant project cost.

Figure 4. Acid sulphate spoil treatment pad at site 6. Lime application and mixing at 5kg/m³ spoil.
