# From Fire to Flood: Lessons learnt from a nature-based reach-scale strategy after 22 years at Stockyard Creek

Hughes, R.M<sup>1</sup>, Farley, G.<sup>2</sup> and Brooks, A.<sup>3</sup>

<sup>1</sup> Soil Conservation Service, Newcastle, NSW, 2302. Email: rhiannon.hughes@scs.nsw.gov.au

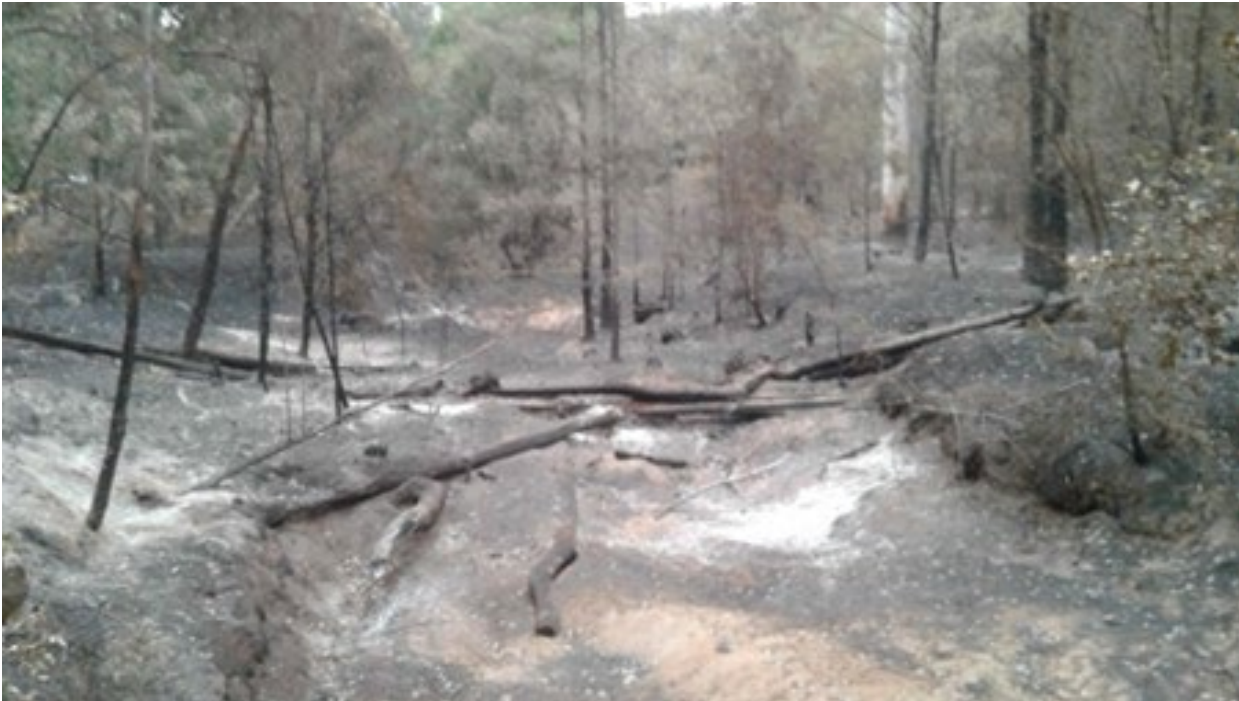
The riparian buffer and majority of the ELJs at Stockyard Creek were burnt during the Black Summer Bushfires 2019/2020. The riparian corridor was mapped as experiencing medium burn severity (partial canopy scorch) by the Fire Extent and Severity Mapping (FESM) dataset for the event and the ridgeline surrounding the site was mapped as high to extreme burn severity (NSW DCCEEW, 2020). Shortly after the Black Summer Bushfires, the study reach experienced multiple high magnitude flood events throughout 2020 to 2022 resulting in geomorphic change within the reach. These events are estimated to be of similar magnitude to

**Figure 2. A photo of the scorched riparian corridor within the Study Reach following the Black Summer Bushfires 2019/2020. Photo provided by the landholder, Brian Woodward.**

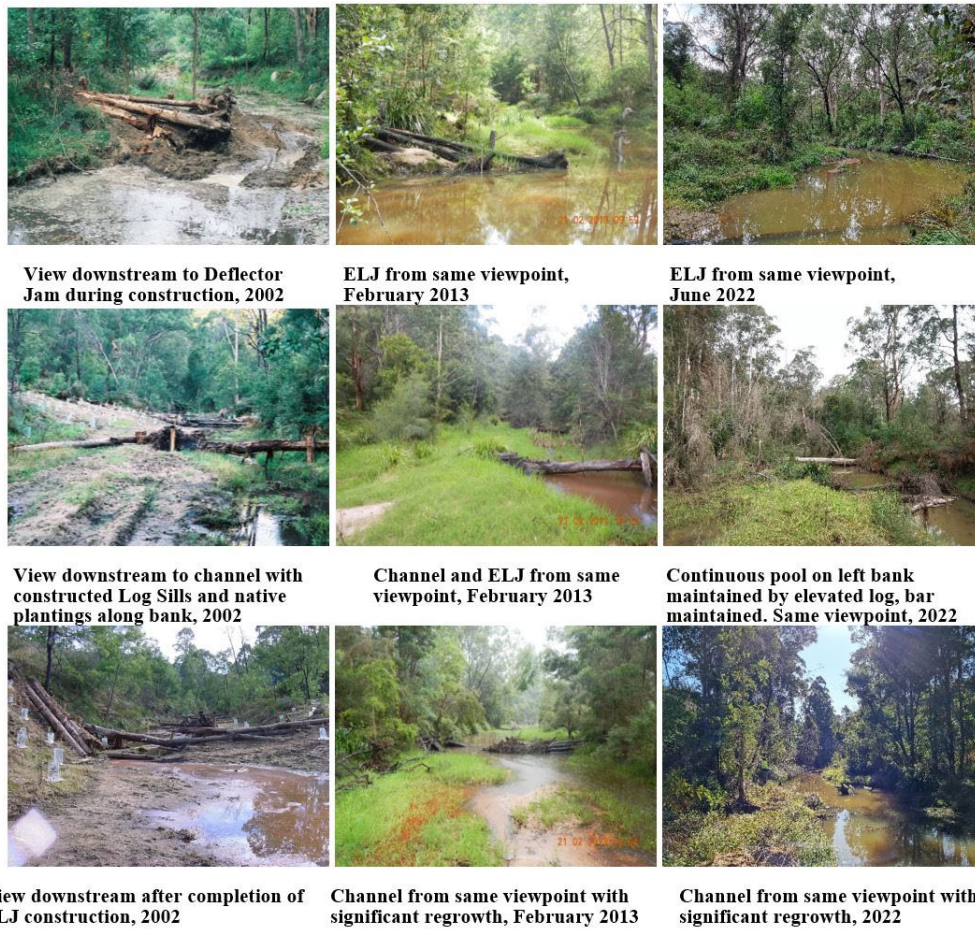
Vegetation throughout the reach is in good condition and dominated by a diversity of native species with vegetation successfully established on and surrounding the majority of ELJs (Figure 3). This may have helped to protect the ELJs from the impacts of fire with only the exposed logs burnt in the event. Natural system recovery is evident with geomorphic features (inset floodplain benches) stabilised by the recruitment of native species and natural accumulations of Small Woody Debris (SWD) (wood with a diameter <0.1m). Large Wood (LW) recruitment, defined as  $\geq 10\text{--}20$  cm diameter and 1–2 m long (Gippel et al. 1996; Wohl et al. 2016), from the riparian corridor was evident. Geomorphic features are still vegetated even after bushfire and multiple high magnitude flood events (Figure 3).

Generally, the structures remained in place but unlike the 2013 structural inspection, majority of the ELJs have experienced some form of structural change because of the bushfires, with 60% experiencing moderate or major change. Log Sill structures experienced the most fire damage, with up to 94% of the Log Sills recorded as fire affected (Figure 4). The top sill/exposed logs were observed to be burnt by fire on majority of structures with the centre of the log sills now performing little influence on bed stability. Due to the sand-bed nature of Stockyard Creek, log sills were built spanning the channel cross-section (approx. 20-30m) to minimise outflanking with key-ins excavated deep into the top of bank. Although the centre of the log sills has been impacted by fire, the key-ins were barely visible and observed to be playing an important role in influencing bar and bank stability and general accretion recovery. The 2013 inspection recorded major change to two of the four Deflector Jams (DFJ) with the remaining two DFJ recorded as 'as-built' condition or having minor signs of change in the current inspection (Figure 4) with significant deposition and bar development identified in association with these ELJs. Anecdotal evidence suggests since the 2013 inspection, the structures within the reach, remained in good condition prior to the fires and despite the impacts of fire and flood, the wood from the ELJs has largely remained in place 22 years after construction. Log members that weren't burnt generally showed minor decay with evidence of biofilm, algae and aquatic flora existing on logs (Daley and Brooks, 2013). We do not believe the observed structural change due to fire damage represents a significant problem to the stability of the reach at Stockyard Creek, as the ELJ function is now largely replicated by the stabilising effect of vegetation on and around the structures.

Figure 3. Example comparison photos taken during the structural assessment through time.

The rapid structural assessment at Stockyard Creek, led to the decision to not repair the ELJs and to let nature take its course.

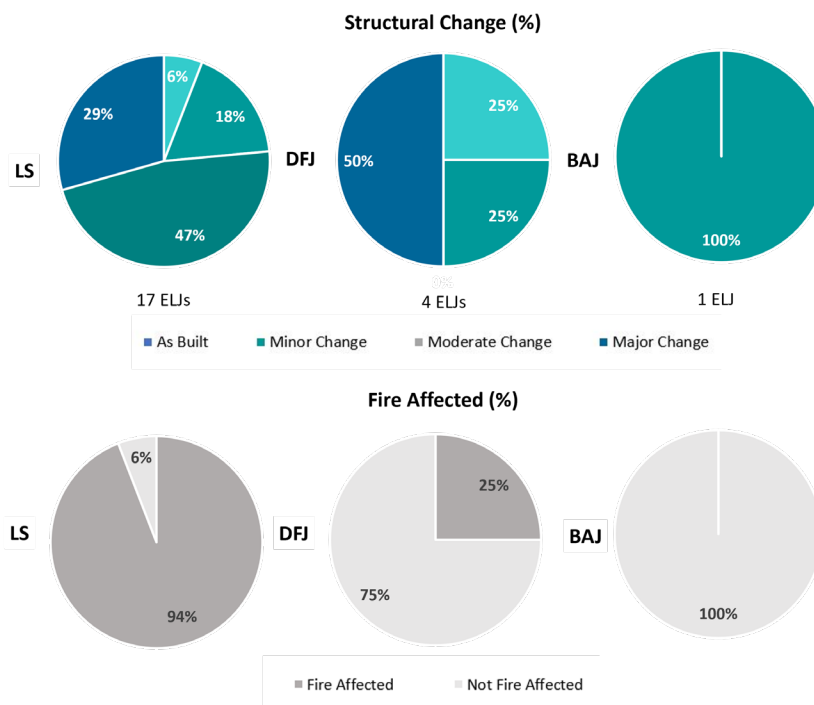
Figure 4. Proportion of structural change and recorded fire impacts for each structure type at Stockyard Creek – Log Sill (LS), Deflector Jam (DFJ), Bank Revetment Jam (BAJ).
