Headwater streams restoration: “Two creek systems are not the same!”

Athapaththu, C.¹, Wheeler, N.¹, Clothier, J.¹, Pearson, B.¹

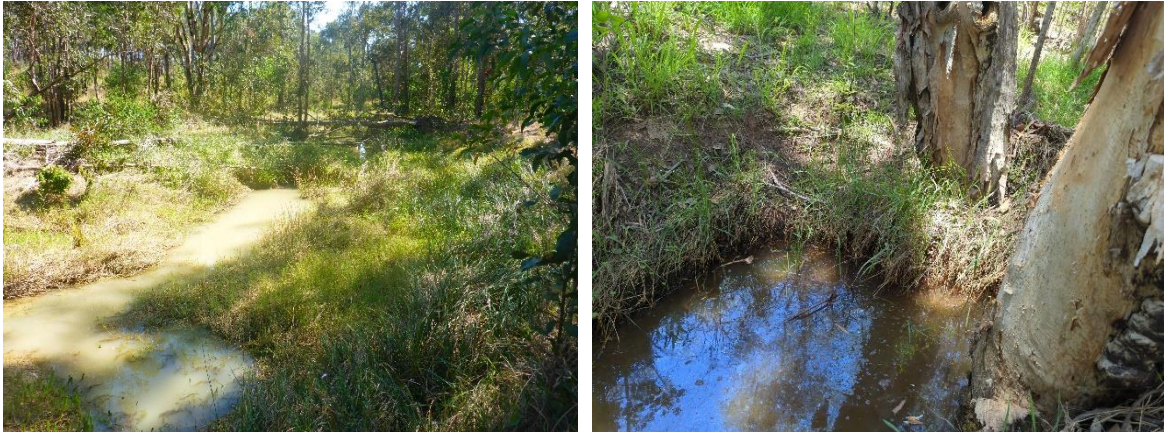
Figure 2. Headward erosion of a pond where vegetation is lacking (left) and a headcut migration stopped by established woody vegetation (right).

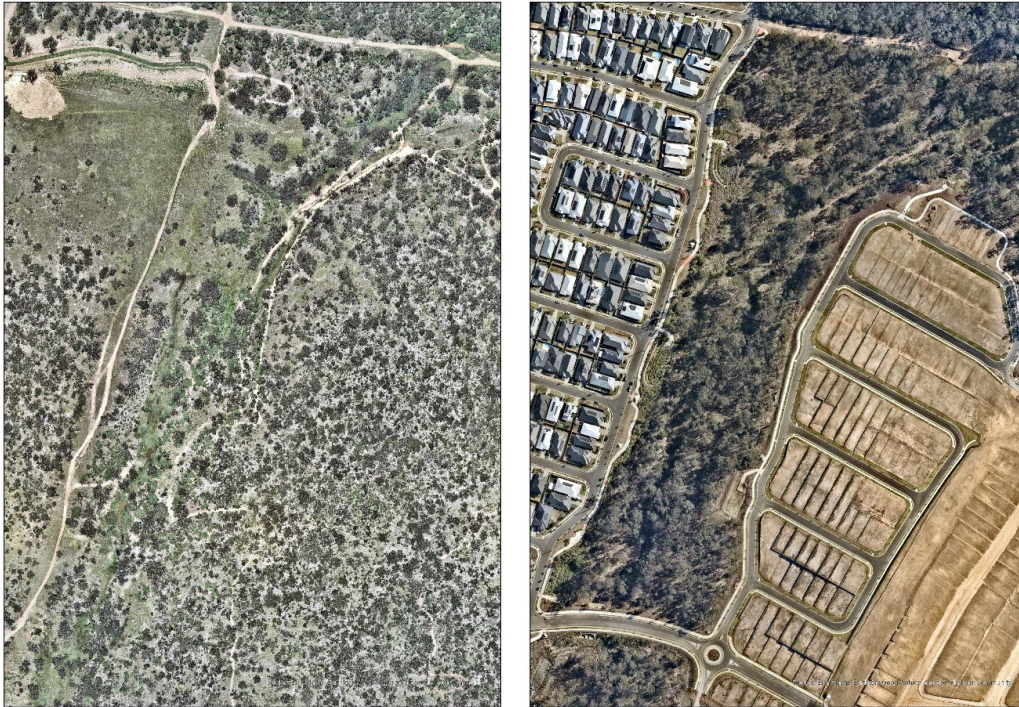
Figure 5. Aerial image of 2017 showing the historical disturbances at the site caused by 4WD drive tracks (left) and aerial image of 2023 showing the intact chain of ponds creek system with well-established vegetation despite the ongoing constructions and urbanization of the catchment (right).

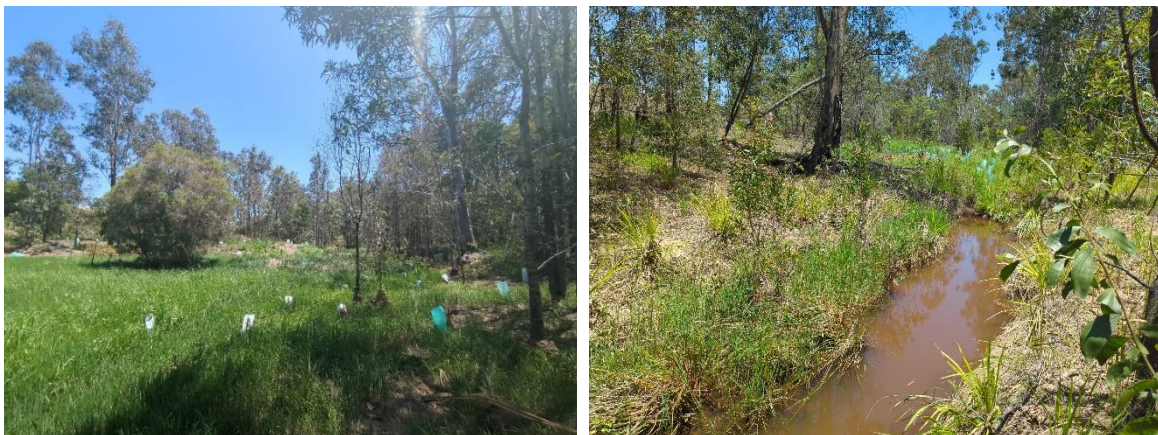
Figure 6. Increased vegetation cover on the floodplain (left) and a rehabilitated gully with stable bed and bank conditions (right).

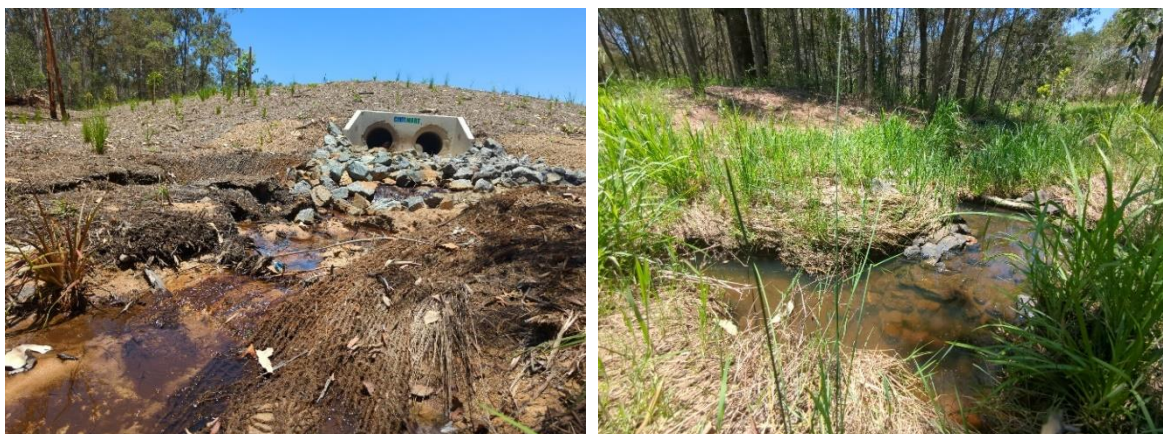
Figure 7. Monitoring findings showing erosion and exposure of subsoils downstream of a bioretention basin outlet (left) and a headcut bypassing a rock chute and migrating upstream (right).
