Cementing Success in Rainbows

After the Thomson River avulsed into Rainbow Creek in 1952, cutting farms in half, the new 15km channel continued to undergo channel migration and deepening, further impacting on farming land and release of sediments to the Gippsland Lakes. In 1979 over 300 concrete groyne structures were built along Rainbow Creek to mitigate lateral migration.

In 2023 these groynes were assessed by engineers and geomorphologists to determine their stability and effectiveness in providing ongoing long-term stability to the system.

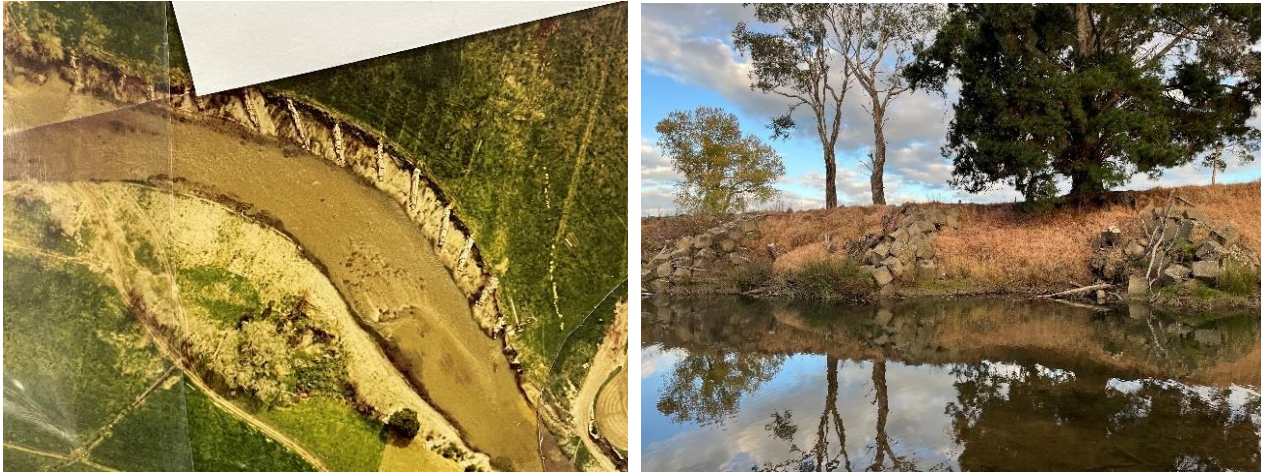
Since 1954, Rainbow Creek experienced ongoing channel adjustment within the floodplain. The impact of these changes on the community were so great, and the governments financial response so little, that a group of locals attempted to secede from the Commonwealth and declare “war” on the State of Victoria. Consequently, in-channel works were funded and undertaken to mitigate impacts of channel changes on adjacent landholders and reduce rates of erosion and sediment transportation into the Gippsland lakes. In 1979-80, a \$1 Million investment (\$6 Million equivalence in 2024) was made to mitigate ongoing lateral river bank retreat, resulting in the installation of 340 concrete groynes (in approximately 35 group locations) along Rainbow Creek (Figure 2 and 3). The groynes were constructed from stacked concrete blocks and secured with stainless-steel cables.

Figure 2. Early 1980's as-constructed aerial imagery of Group E groynes (left), current condition of groyne (2023) (right)

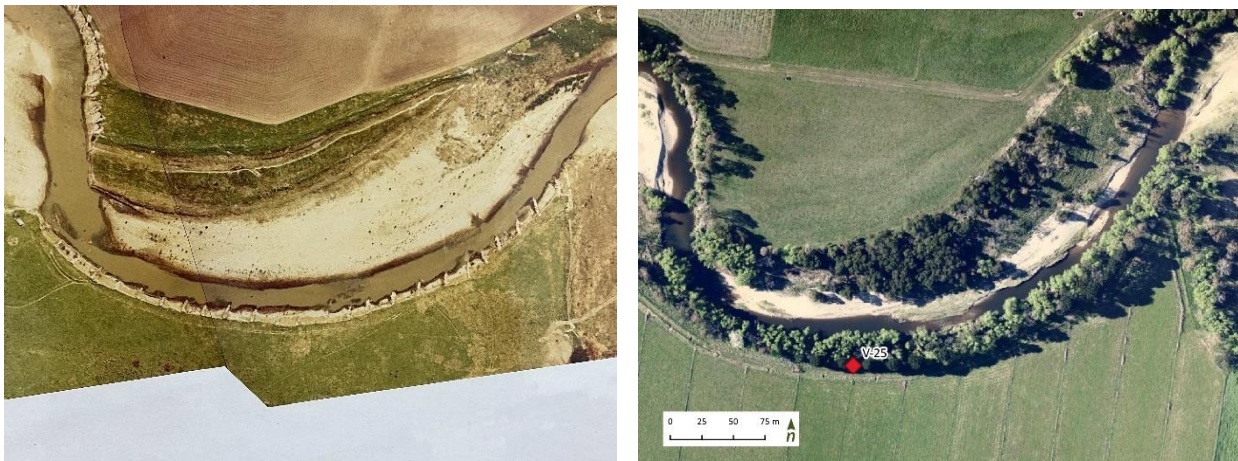
Figure 3. Early 1980's as-constructed aerial imagery of Group V groynes (left), current condition of groyne site (2018) (right)
