Site level vegetation and sediment processes observed over a decade of river rehabilitation

Coates-Marnane et al., – A decade of reach scale river rehabilitation

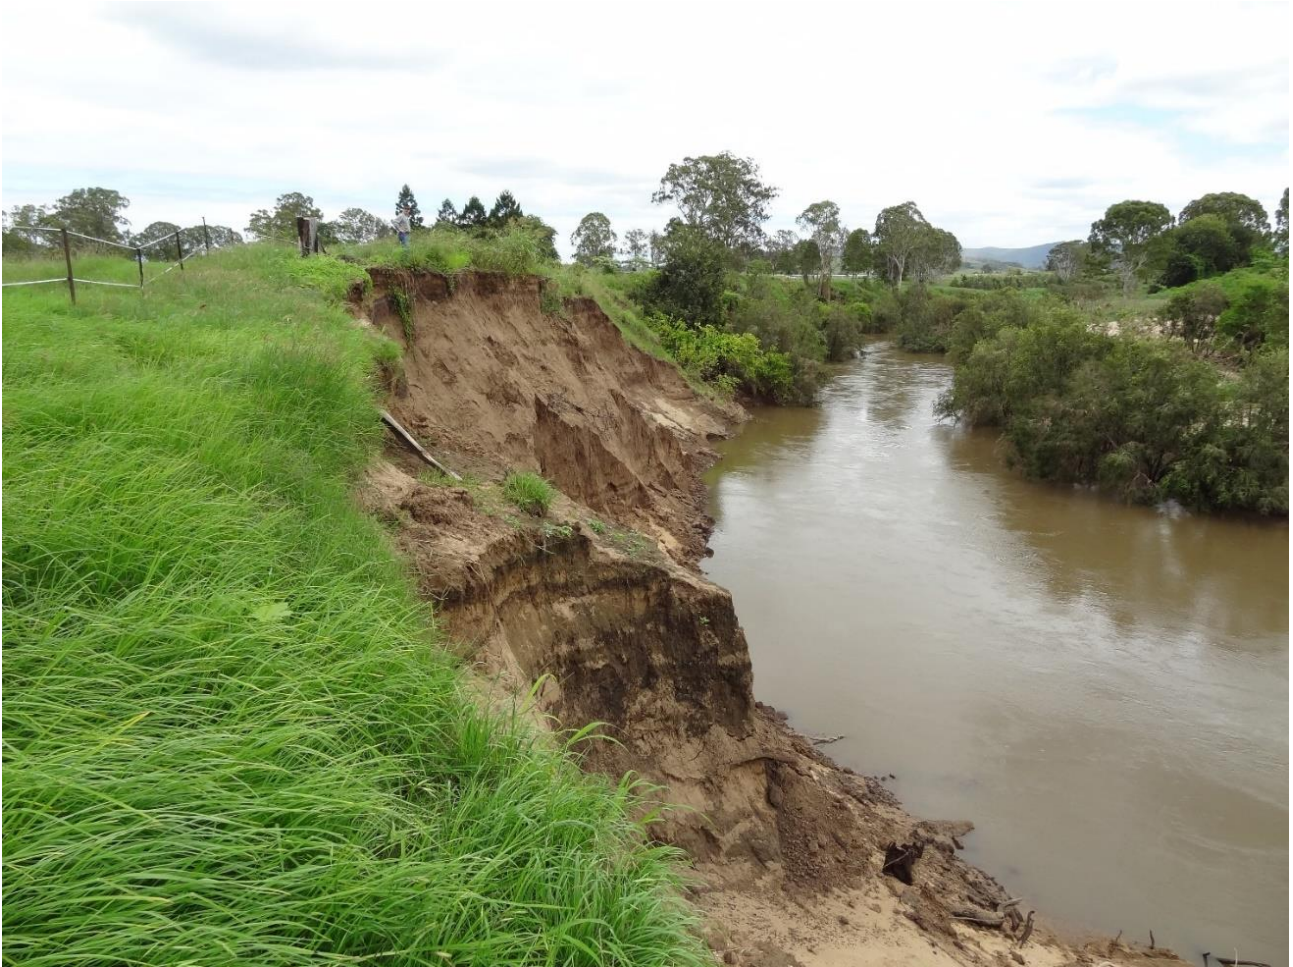
Figure 1. Site 1 prior to rehabilitation works showing extensive vertical eroding banks

Site 1 stretches approximately 310 m of riverbank that in many places had sheer cliff faces upward of 10 m. Initial works included bank reprofiling and battering, emplacement of a rock toe, strategic use of infertile Vetiver and revegetation with a mix of native species, including; *Eucalyptus tereticornis*, *Casuarina cunninghamiana*, and *Melaleuca viminalis*. This process involved the removal of soil from the cliff to create a gentler slope that reduces the likelihood of erosion (or 'mass failure') when moderate to high flow events occur. At the downstream point of this 310 m stretch of river, a pile field has been established (Figure 2). The aim of the pile field was to slow the velocity of flood flows and in doing so, reduce the erosive potential of the water, which causes sediment to drop out of the water column, increasing beneficial sedimentation on the project site.

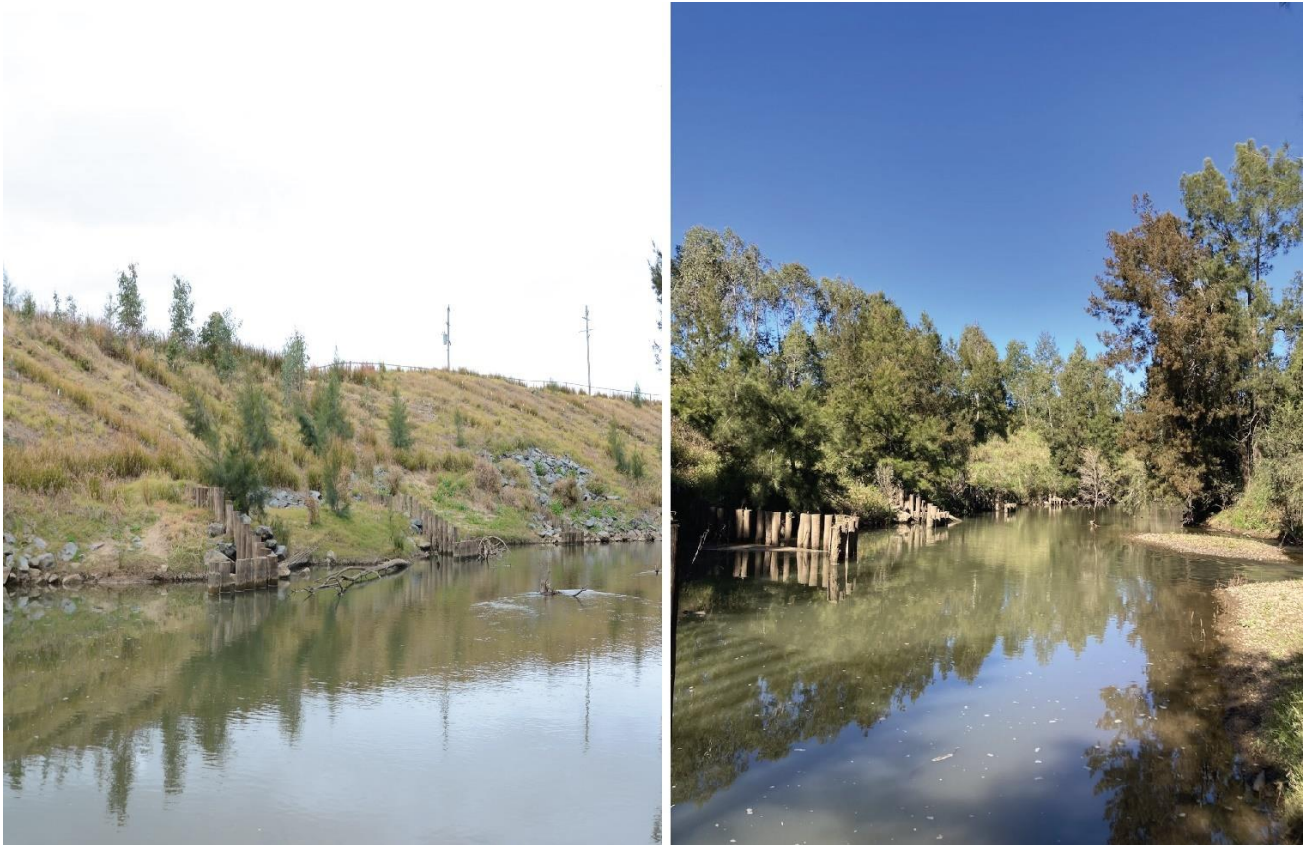
Figure 2. Site 1 in 2015 (left) and in 2023 (right)

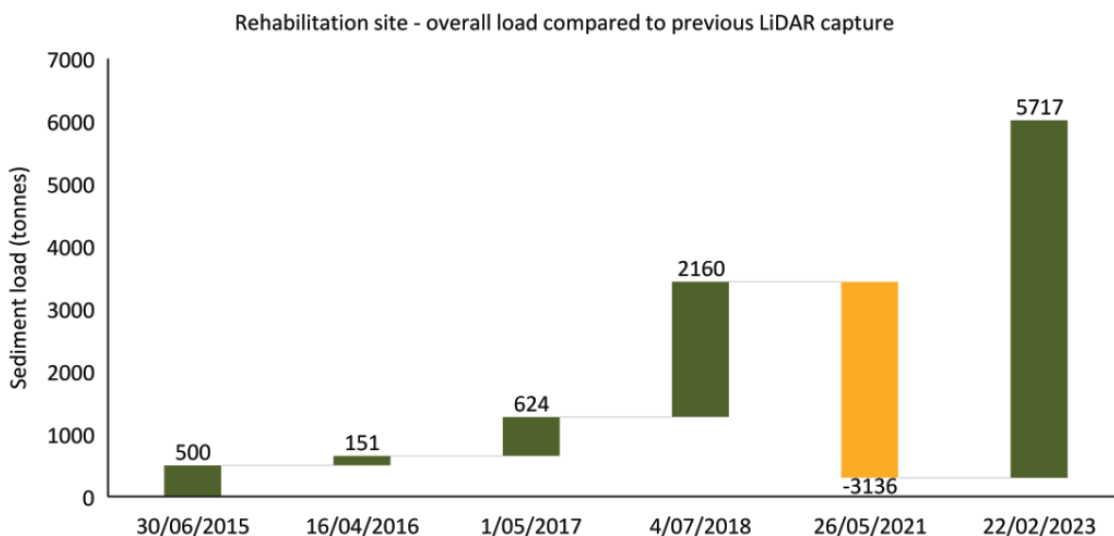
Figure 3. Rehabilitation site overall sediment load compared to previous LiDAR capture

Since site establishment there has been an overall net accretion of sediment to rehabilitation sites 1 & 2 (Figure 3,4). Since initial works were established there has been a progressive increase in sediment deposition at the site. The greatest increase in sedimentation was observed between 2017 and 2018 (> 2000 tonnes), covering the period of the 2017 major flood caused by rainfall from ex-tropical cyclone Debbie (Figure 5). Between 2018 and 2021 a substantial export of sediment from the site occurred, covering the period of the January 2021 major flood event (Figure 2). Between 2021 and 2023 substantial deposition of sediment occurred at the site (> 5000 tonnes), covering a period of multiple floods including the 2022 major flood. The presence of recently deposited (<10 years) flood derived sediment (>0.3 m in depth) at locations across the rehabilitation site were confirmed in field survey in 2023 (Figure 4c).

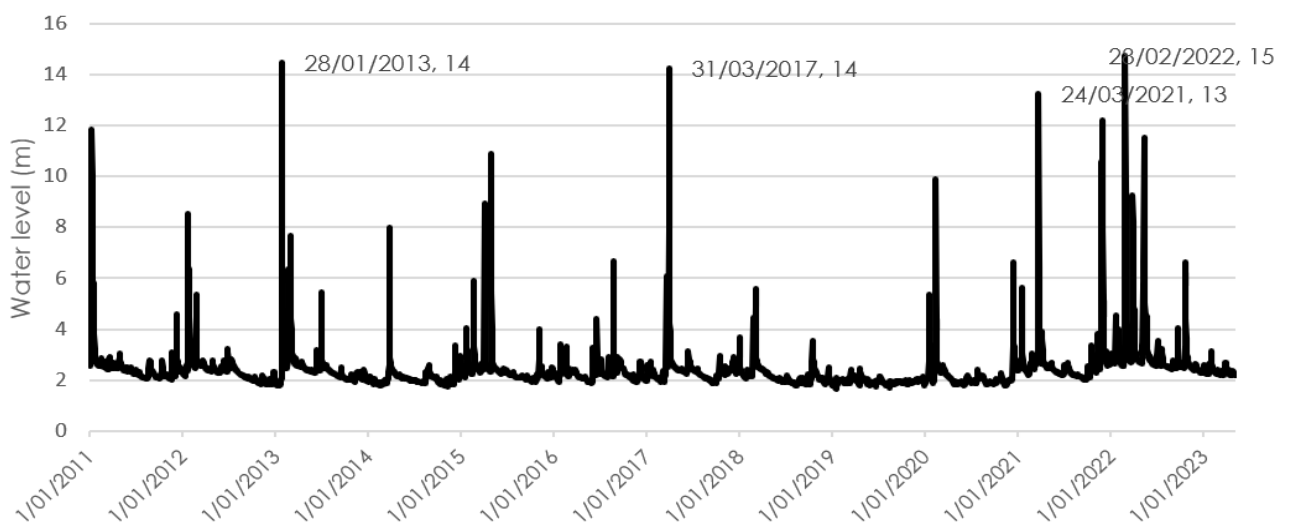
Figure 5) Water level measured at Round Mountain (145008A) from 2011 to 2023.

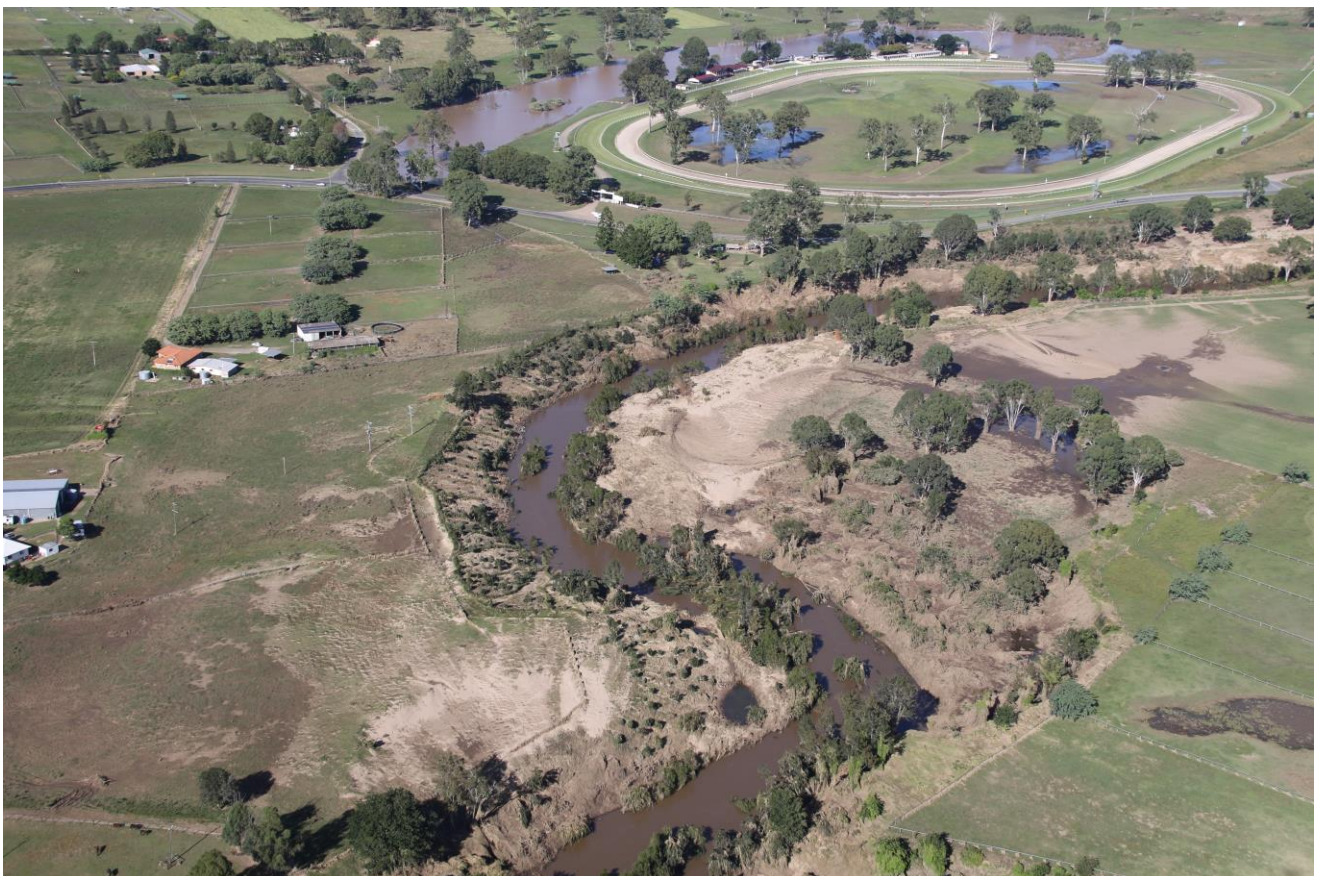
Figure 7. The rehabilitation site on the river following a major flood caused by rainfall from ex-tropical cyclone Debbie – March 2017.
