Post-fire erosion mitigation investigation and trial in the Warragamba drinking water catchment

Rebecca Mabbott¹

1 Soil Conservation Service, Parramatta NSW 2150. Email: rebecca.mabbott@scs.nsw.gov.au

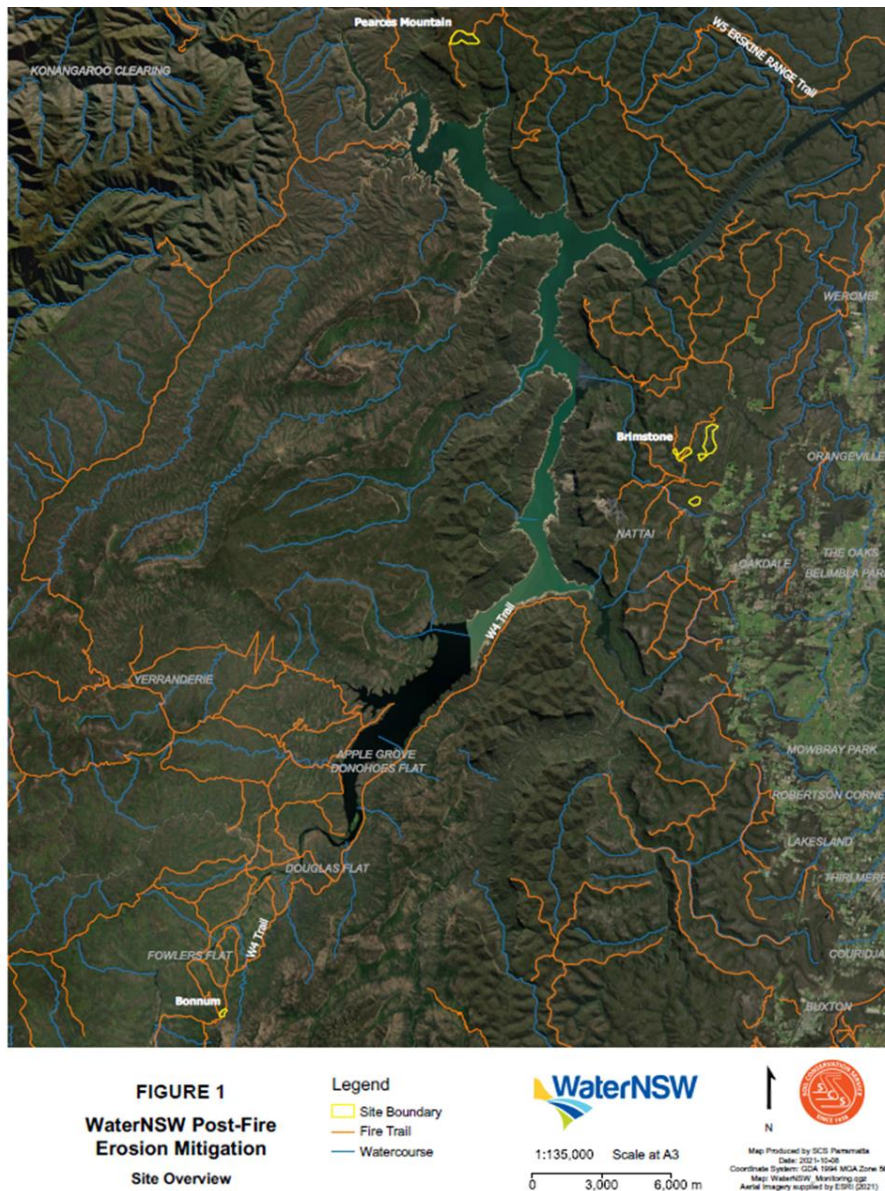
Figure 1. Overview of erosion mitigation and monitoring site locations

Three sites in the Warragamba Catchment were selected for the project as displayed in Figure 1 and listed in Table 1. The final sites were selected from a list of potential sites identified in the post-fire catchment assessment (SCS, 2020). These sites were considered to have the most prevalent ongoing impact from the 2019/20 fires and effectively represented a range of landscape settings in the Warragamba Catchment.

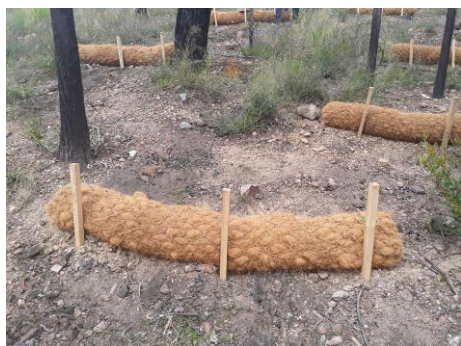
Figure 2. Example of installed coir logs.

Coir logs were effective for capturing hillslope sediment (6.5 T), particularly from concentrated sources such as fire trail drains (Figure 4-A). The staggered coir log pattern with a concentrated array of multiple coir logs was effective at capturing sediment and dispersing overland flow to prevent rilling. Sediment captured behind coir logs provided a stable area for vegetation to establish, particularly in steeper areas of bare rilled earth. Coir log placement should be concentrated below fire trail drains, natural areas of concentrated flow (rills), and across bare areas of stripped soil. However, they should not be placed in established drainage lines (e.g. gullies, creeks, etc.) with entrenched channels, as they will not withstand the flow conditions. Coir logs

remained effective over 12 months post-installation and the majority remained effective despite moderate animal disturbance. The coir logs have an expected lifespan up to 2 years: however, the vegetation colonising the captured sediment will take over the role of long-term stabilisation prior to the coir logs decomposing. No substantial adverse impacts were recorded from the coir log installation.

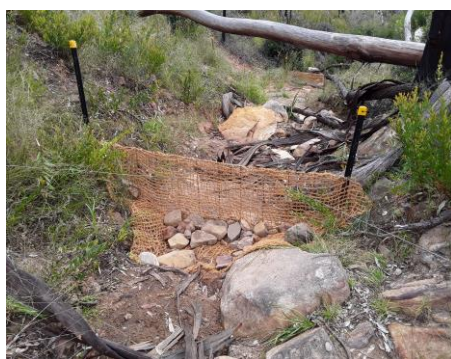
Figure 3. Example of installed channel sediment capture structures.

The channel structures were an effective method of capturing sediment (approx. 4.7 T) and withstood bankfull flow conditions (approx. 1-1.5 m deep x 2-2.5 m wide) without failure. The combination of reinforcement mesh, chicken wire and jute mesh across the structure was very effective at pooling water upstream of the structure to promote sediment deposition. The vertical mesh panel became blanketed in fine sediment and leaf litter that reduced the permeability of the mesh and improved its water holding ability. Minor erosion occurred immediately downstream of the structures, however the erosion did not compromise the effectiveness of the structures or exceed the volume of sediment captured by the structures.

The channel structure design was effective for single spans across channels up to 2.5 m wide where bedrock beds or boulder beds inhibit additional mid-channel star pickets. If channels have a sediment bed that allows for additional mid-stream star pickets for reinforcing the structure, then wider spans could be achieved. The channel structures require channel banks that are higher than the structure (i.e. 0.7 m high) to allow for it to be keyed into the banks. The channel structures withstood the flow from a relatively steep catchment with an area of approx. 9.5 ha and channel gradient of approx. 14%. It is assumed that a catchment up to this size and gradient would be suitable for this structure design. Due to the structures withstanding overbank flows, they could be suitable for larger catchment with lower channel gradients (i.e. higher discharge but lower flow velocity). It is recommended that the positioning of channel structures is assessed by an experienced professional with knowledge of watercourse character and behaviour to prevent adverse impacts from structures. The channel structures are expected to have a lifespan of over 20 years. However, the captured sediment is becoming recolonised by in-channel vegetation which will take over the role of long-term stabilisation prior to the structure's design lifespan.
