# Hydrological Restoration of the Critically Endangered Fleurieu Peninsula Swamps Ecological Community

Ben Taylor<sup>1</sup>

<sup>1</sup> Nature Glenelg Trust, Prospect, SA, 5082. Email: [ben.taylor@nqt.org.au](mailto:ben.taylor@nqt.org.au)

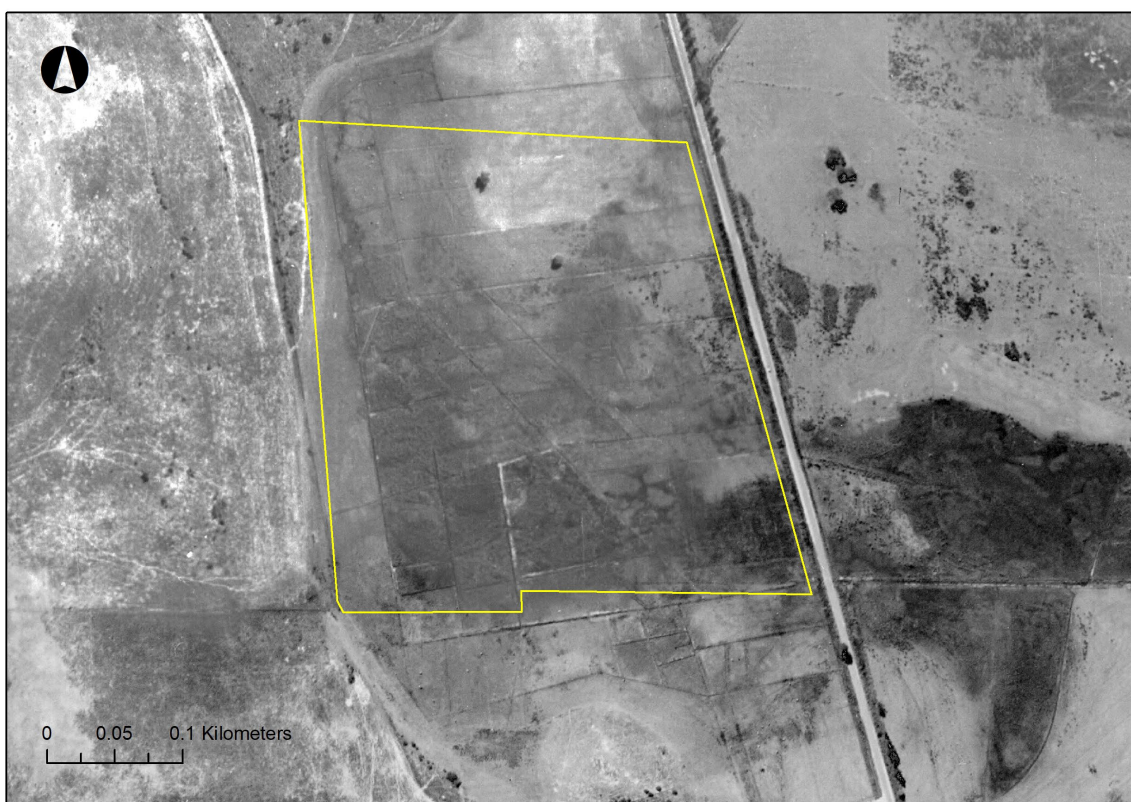
**Figure 2. 1949 aerial image of contemporary Hesperilla Conservation Park (yellow polygon).**

Hydrological restoration was not a focus of FP Swamp recovery for some years, yet water regime is a fundamental driver of wetland ecosystems and anthropogenic alteration of natural water regimes has occurred in many remnant FP Swamps, including some of the largest and most intact remnant sites. For example, Hesperilla Conservation Park (proclaimed 2010), a relatively intact FP Swamp, has an extensive history of drainage and clearance (Bachmann and Farrington 2017). The earliest aerial image of Hesperilla (1949) shows the swamp largely clear of native vegetation and featuring a network of drains (Figure 2). Analysis of historic aerial imagery in other parts of the Fleurieu Peninsula has revealed similar evidence of intensive efforts to drain swamps for conversion to agriculture (Bachmann and Farrington 2016, Farrington et al. 2017). Without remediation, these drains continue to adversely affect swamp hydrology and therefore swamp ecosystems.

Although the FP Swamp vegetation has naturally regenerated within Hesperilla CP, and other sites with similar land-use history, our contention is that the network of old drains within these swamps is having an ongoing hydrological impact that is compromising the FP Swamp ecosystem. Ongoing impacts are likely to include:

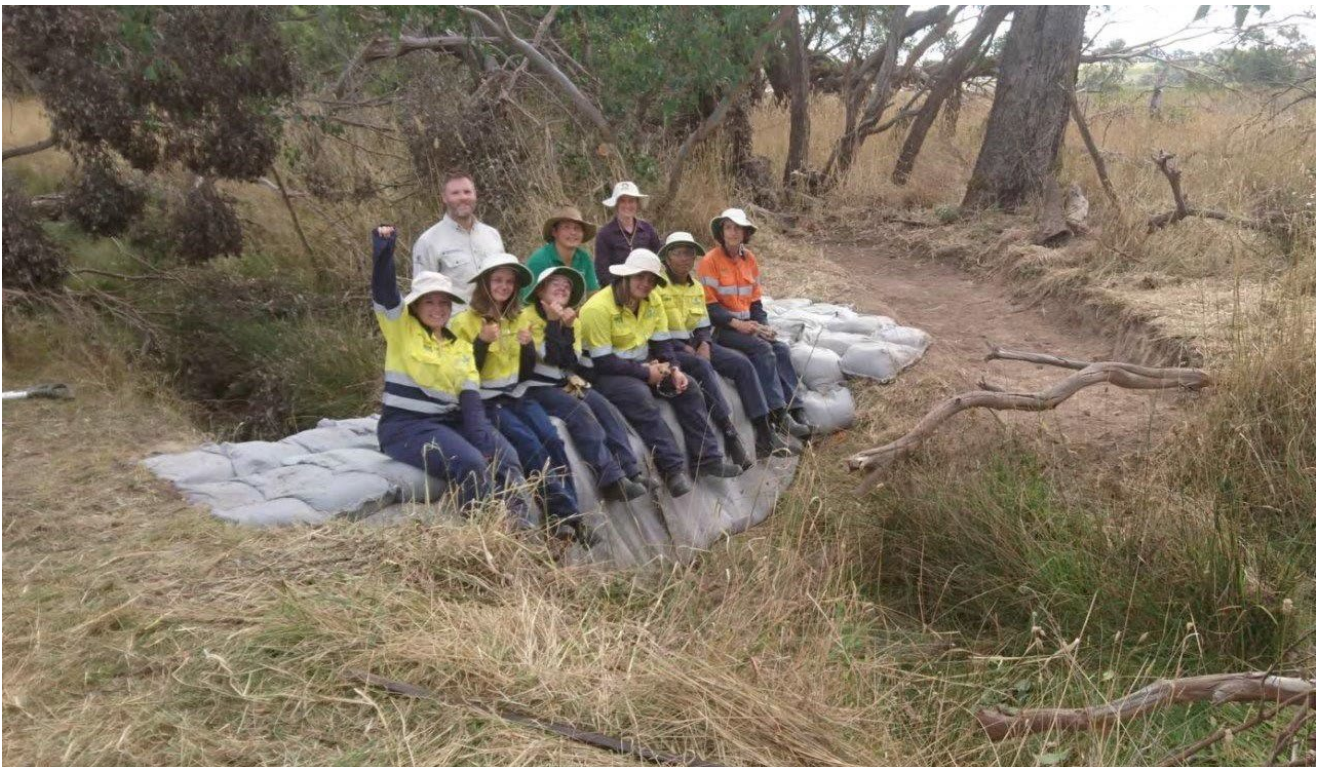
**Figure 4. Community volunteers and a recently completed sandbag structure, 5/4/2017. A cutting has been made through the spoil mound of the drain, to the right of the structure, to facilitate lateral flow into the natural creek meanders.**

Plans to remediate these drains were developed (Bachmann and Farrington 2016) and have been implemented in a staged manner since autumn 2017. Initially, with the assistance of volunteers, a series of geofabric sandbag structures were installed along the inflow drain to lift water out of the drain and re-engage the natural creek meanders (Figure 4). These structures also directed seasonal surface flows back into Glenshera Swamp for the first time in around 70 years (Figure 5). The advantages of sandbag structures are their low cost and ease of adjustment, by adding or subtracting bags, enabling hydrological restoration concepts to be trialled and, where required, modified. However, these structures are prone to damage by high flows, as has occurred at Glenshera, and the geofabric eventually degrades in sunlight.

A second phase of works involved the use of a small excavator to bury the sandbag structures, i.e. to make them permanent. For erosion control, coir netting was placed over the buried structures; complete overtopping of these structures is likely to occur in extreme flow events. Complete backfilling of the inflow/bypass drain was not possible because erosion over c.70 years had increased drain volume so that the remnant spoil originally excavated, which lies parallel with the drain long its length, was of insufficient volume. However, complete backfilling was achieved in some strategic locations where sufficient spoil could be gained without disturbing native vegetation or creating an erosion risk.

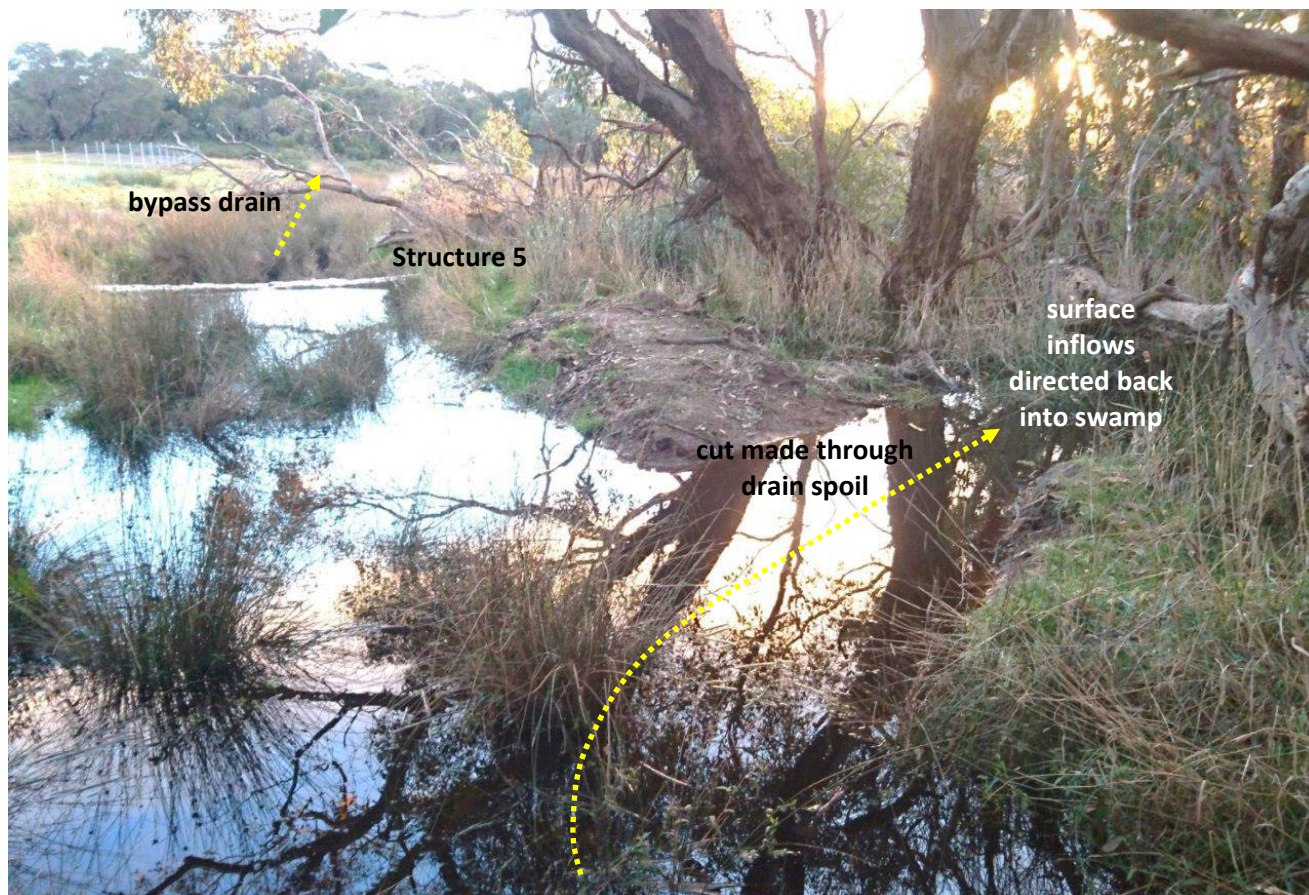
**Figure 5. Surface inflows redirected back into Glenshera Swamp by Structure 5, winter 2017.**

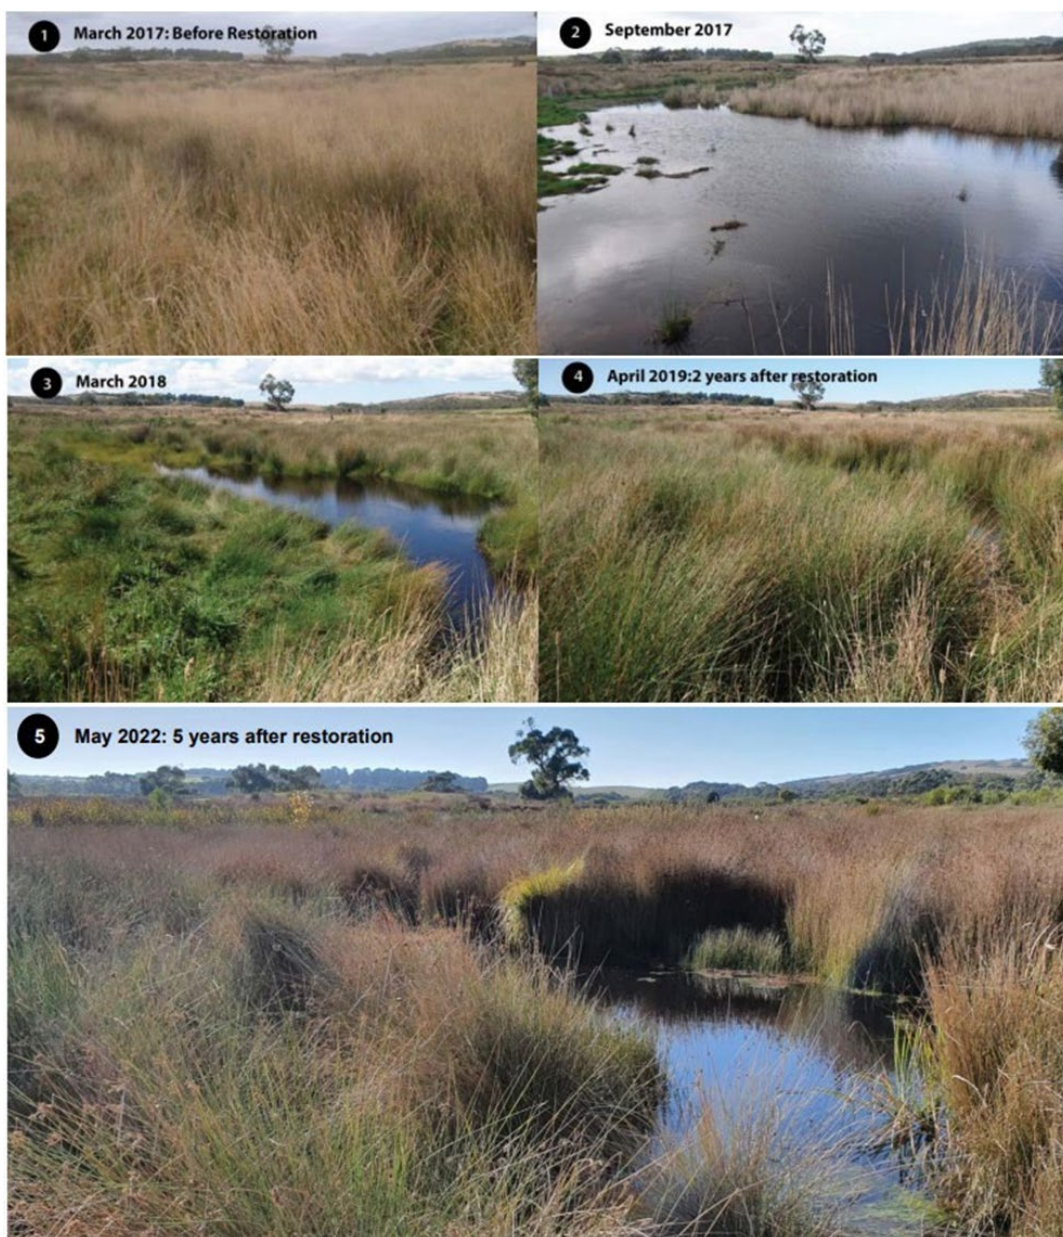
Figure 7. Time series showing displacement of introduced pasture grasses (mostly *Phalaris aquatica*) by native sedgeland (mostly *Juncus sarophorus*) facilitated by hydrological restoration.
