The use of long-term monitoring data to inform the analysis of, and prognosis for, an incised stream system: The Cann River in Far East Gippsland, Victoria, Australia

Ross E Hardie¹, Alex Sims¹, Sean Phillipson²

1. Alluvium Consulting Australia Pty Ltd, East Melbourne, VIC, Australia

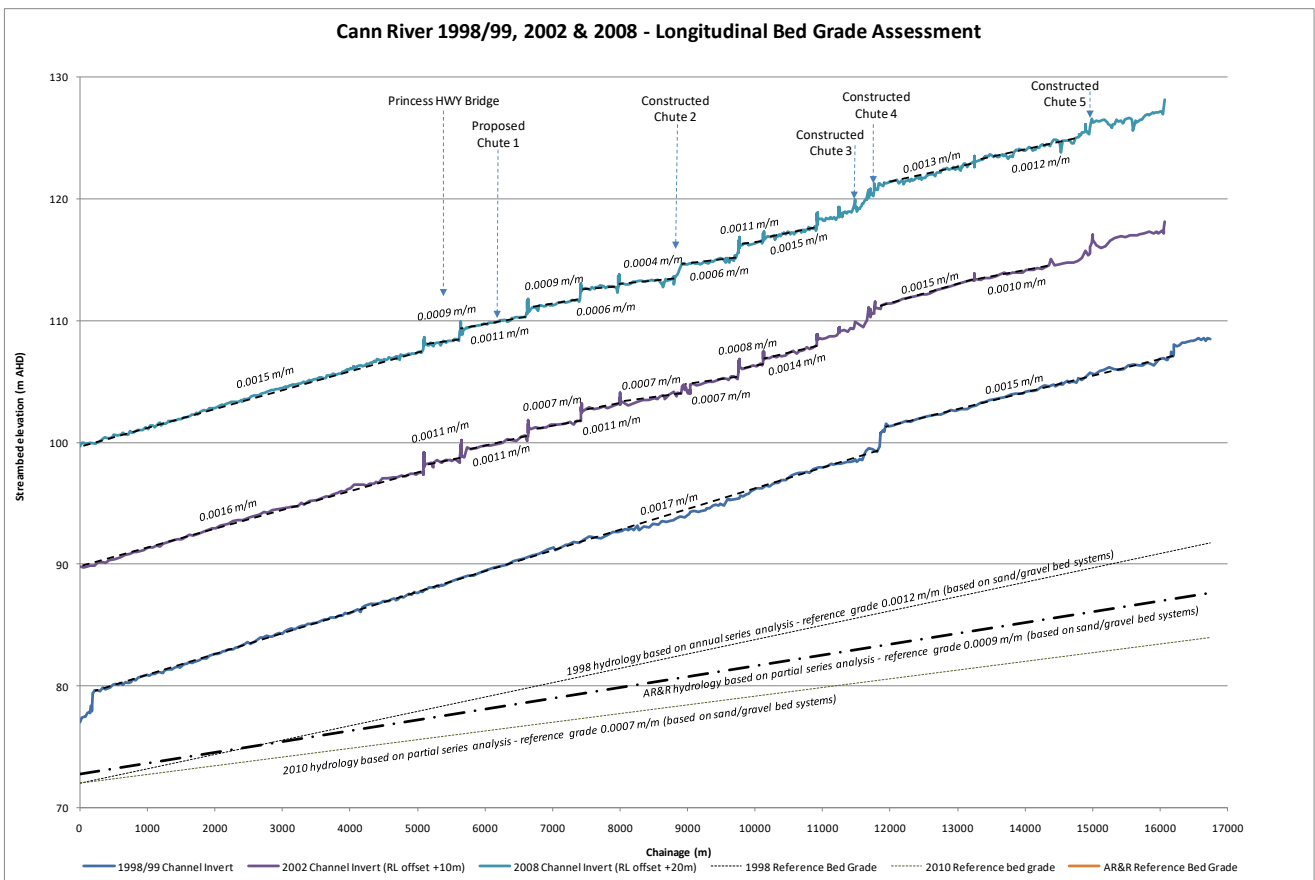
Figure 2 Cann River bed grades 1998 to 2008 and bed grade analysis: note elevation of 2002 and 2008 bed grades have been offset vertically by 10m and 20m respectively to aid visualisation.

Grade control works were installed in two phases (See Figure 1 and Figure 2):

- four major grade control structures, nine intermediate structures and a vegetation establishment and management program were installed in the reach upstream of the Princess Highway Bridge in 1999. The primary grade control structures were based on an estimated long-term bed grade in the Cann River. The bed grade adopted for the design of the 1998 flood recovery program was 0.0013 m/m (refer figure 2) i.e. less than the observed 0.0015 to 0.0017m/m grade observed in the system.
- nine additional intermediate structures were installed in the reach downstream of the Princess Highway Bridge, accompanied by installation of large wood (logs) aimed at creating localised scour for habitat in 2010. The location and number of grade control structures was designed based on what was observed at the time as a developing bed grade of between 0.0012 and 0.0006m/m.

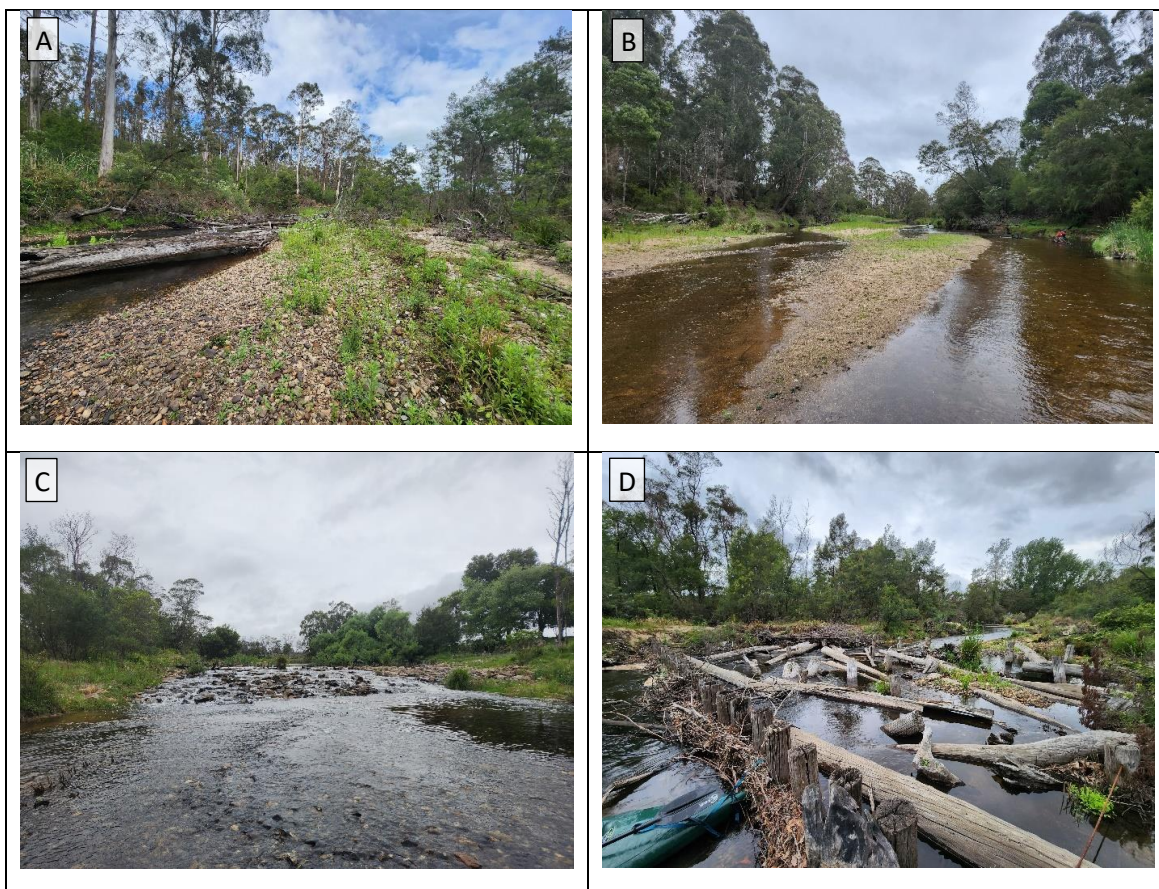
Figure 3. Coarse gravels that dominate the upper section of the study reach (A), sandy sediment downstream of Chute 5 (B), looking upstream at a rock chute (C), the crest of an intermediate structure which has lowered by $\sim 1\text{m}$ (D). All photos captured November 2023.

(Figure 3D) was to limit (but not halt) the rate of bed incision. Limiting the rate on incision allows for the grade of the channel bed to adjust while, in theory, promoting vegetation establishment in the backwater of the structures. Intermediate structures in the upstream reach are intended to compliment the rock chutes and prevent the toe of the chutes from being undermined (Figure 3C). The intermediate structure in the downstream reach were intended to limit the rate of incision that would be triggered by a reduction in sediment supply from the upstream reach (i.e. the downstream structures address the unintended consequences of halting incision in the upstream reach).

Exposed bedrock and coarse gravel dominate the upper reaches of the study reach (Figure 3A), compared to a dominantly sand bed prior to 1998. Sediment calibre generally fines in a downstream direction and the bed is largely free of bedrock outcrops and is sand dominated from 3 kilometres upstream of Chute 5 onwards (Figure 3B). All rock chutes were intact (Figure 3C) and backwaters, approximately 1 m deep, were present immediately upstream. The condition of intermediate structures varied and the crest height of the structures, marked as the elevation of the rock boulders placed between the rows of piles, was up to 1 m below the top of the piles (Figure 3D).

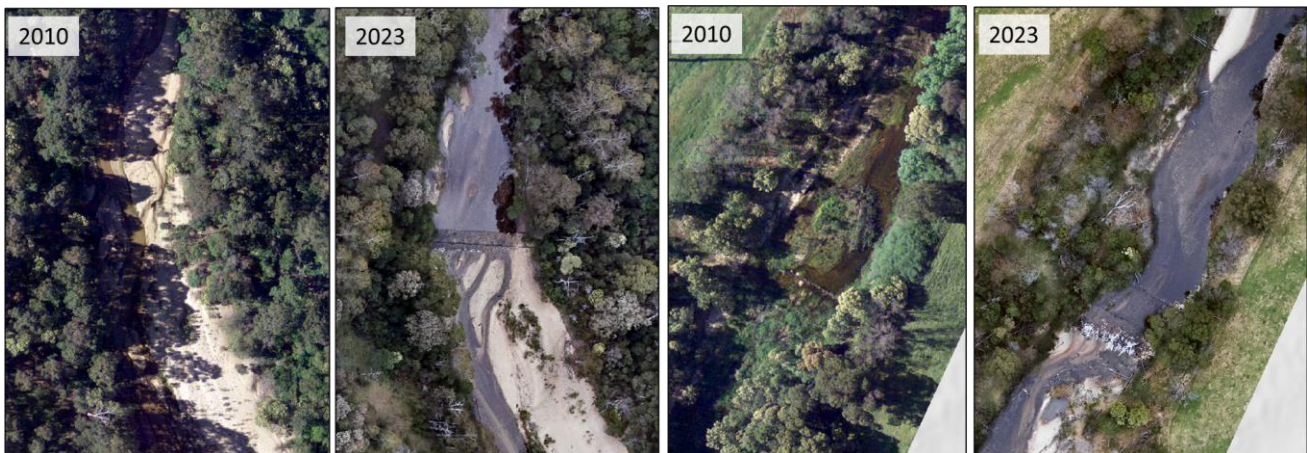
Figure 4. Changes in bed structure and vegetation at two intermediate structures. Aerial imagery captured in 2010 and 2023.

Aerial imagery captured in 2011 and 2023 confirms the loss of sand and decrease in bed level at each of the intermediate structures (Figure 4). Beds of *Phragmites* that had colonised sand deposited immediately upstream of the structures in 2010 were largely gone by 2023 but at some structures, *Phragmites* patches had been replaced by woody vegetation. Bed erosion was concentrated between existing terraces that were already in place by 2010, with only minor erosion at the toe of those terraces.

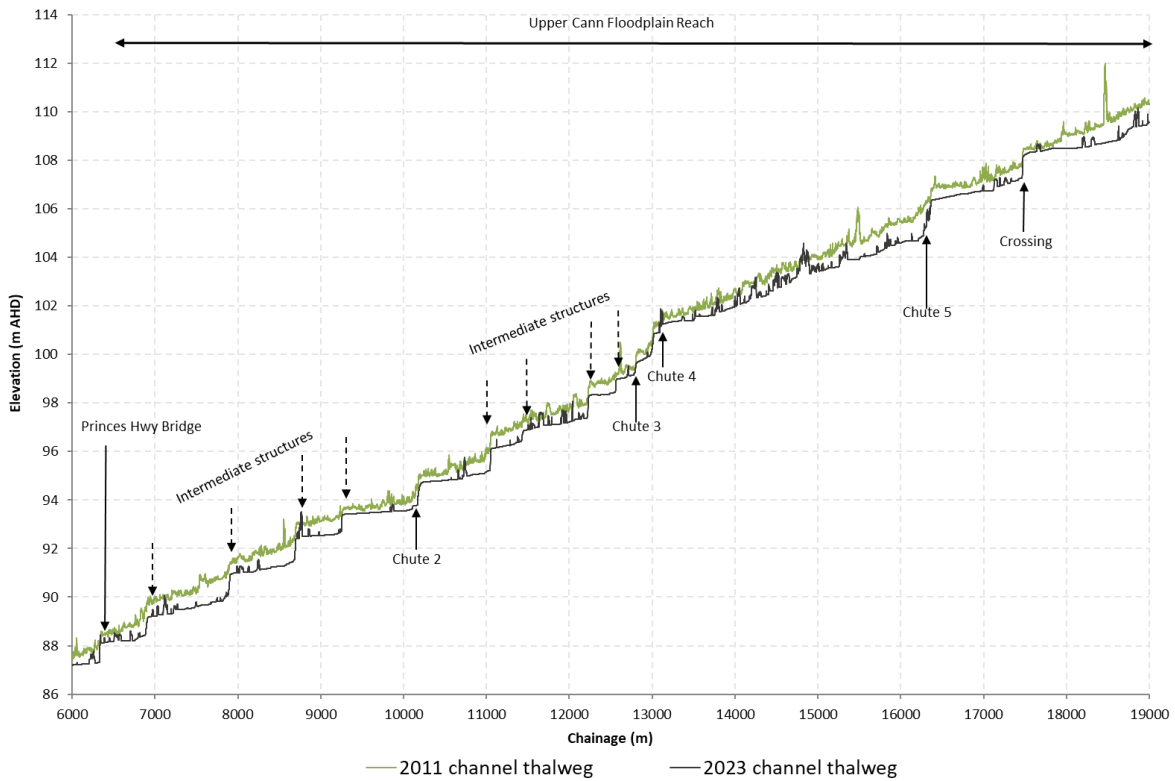
Figure 5. Longitudinal profiles extracted from DEMs surveyed in 2011 and 2013 for the reach upstream of the Princess Highway Bridge.

Comparison of the 2011 and 2023 longitudinal profiles revealed a stark pattern of bed level lowering along the entire study reach (Figure 5, Figure 6). The crest elevation of all intermediate structures appears to have dropped, but incision was greatest immediately downstream of each intermediate structure, producing a step-like profile by 2023. The pattern of greater bed level lowering downstream of structures led to an overall decline in grade between all structures, but the total magnitude of incision was greatest in the reach downstream of the Princess Highway (Figure 6). While the crest of the rock chutes remains intact, the longitudinal bed profile (Figure 5) indicate that there has been some bed lowering at or immediately adjacent the crest. With the exception of chute 2, the 2011 and 2023 profiles at the crest of each chute overlap, suggesting that sediment (rather than rock) has been eroded from the bed immediately adjacent the crest. The reason for the slight mismatch in bed profile at chute 2 is unclear, and may be a result of uncertainty in the corresponding DEMs.

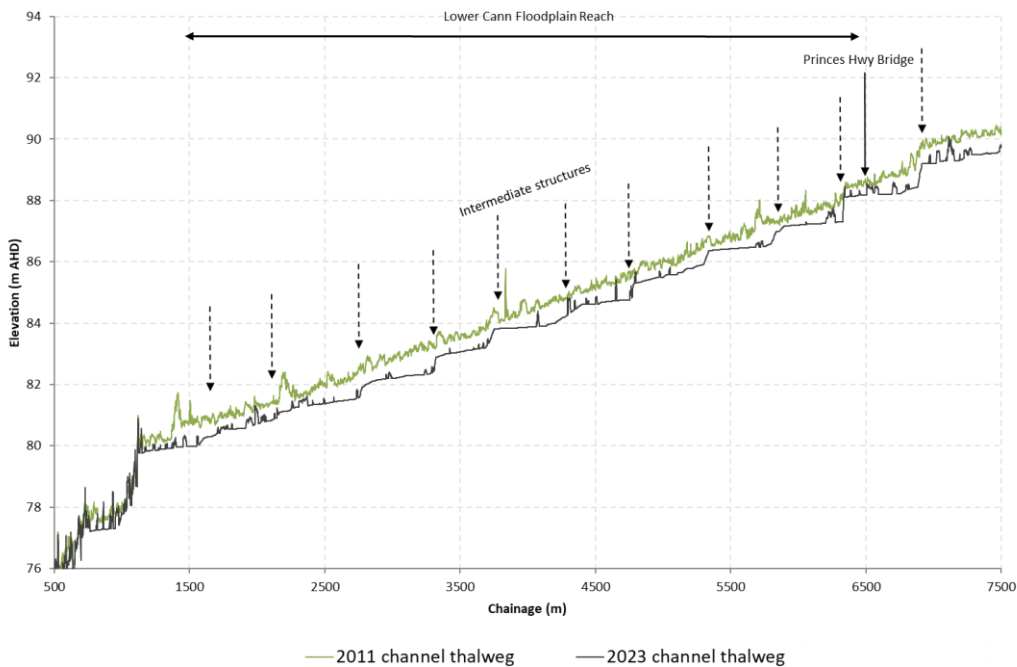
Figure 6. Longitudinal profiles extracted from DEMs surveyed in 2011 and 2013 for the reach downstream of the Princess Highway Bridge.

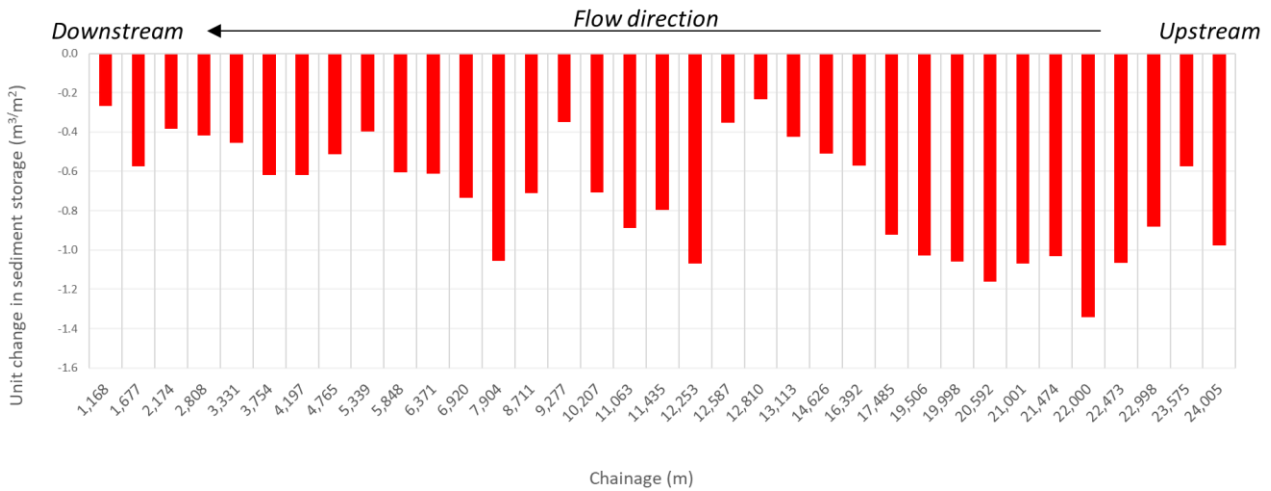
Figure 7. Unit change in sediment storage in each sub-reach of the Cann River between 2011 and 2023

The unit change in sediment storage in each sub-reach (where a sub-reach is the area between successive intermediate structures, or a 500 m length – whichever is less) revealed net sediment loss in all sub-reaches (Figure 7). The magnitude of that loss in sediment storage declined in a downstream direction so that upstream reaches had lost, on average, double the unit volume of sediment than downstream reaches between 2011 and 2023.

Scouring occurred along much of the channel bed throughout the study reach (as evident by the changes in longitudinal profile elevation), which, in some areas, led to deposition on some of the adjacent benches. Erosion was also focused on the outside of meander bends, while relatively minor levels of deposition occurred on the opposing point bars. Together, the changes in bed elevation and bank erosion resulted in the net export of approximately 547,000 m³ of sediment from the study reach between 2011 and 2023.
